TISO 10kW: THE OLDEST GRID-CONNECTED PV SYSTEM IN EUROPE

L. Fanni, A. Realini, E. Burà, D. Chianese

University of Applied Sciences of Southern Switzerland (SUPSI)

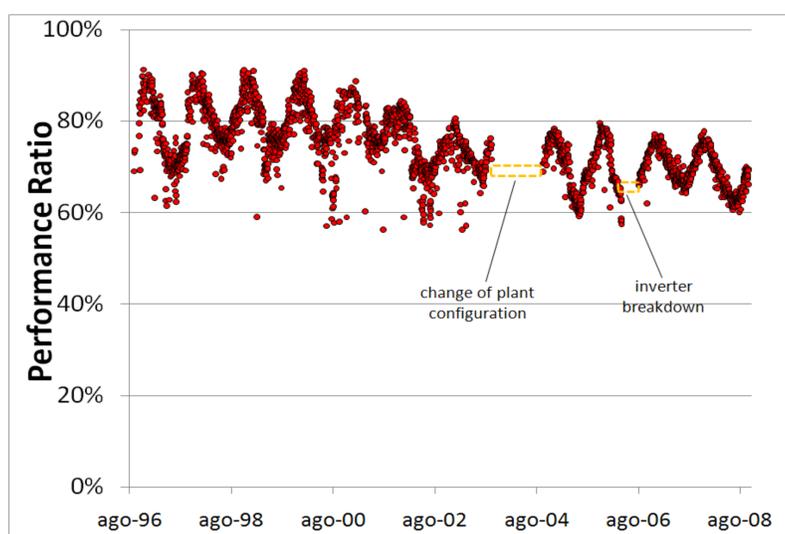
The plant worked since 1982 until 2008 when it has been dismantled from the original roof in order to be rebuilt on another roof (end 2010). After 26 years the PR value under real working conditions (not T-corrected) is around 70% of the nominal value.

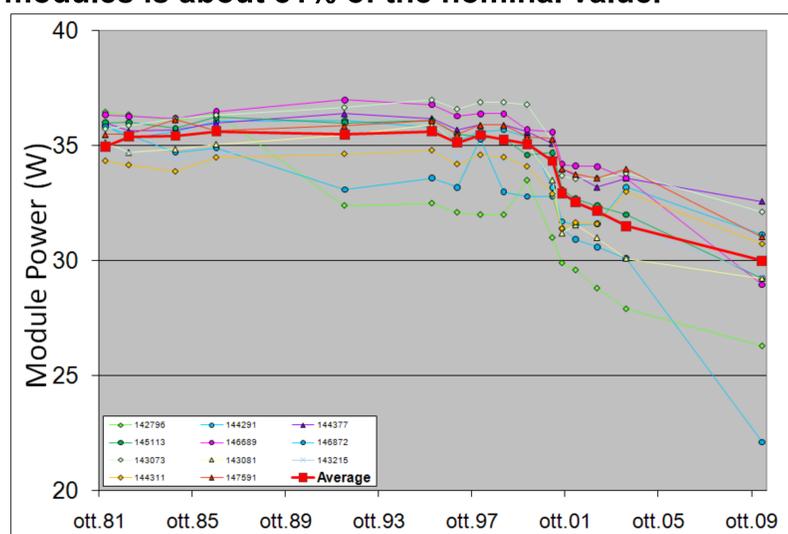
Since 1982, indoor measurements on a batch of 18 modules have been periodically executed. After 28 years the average power of these modules is about 81% of the nominal value.

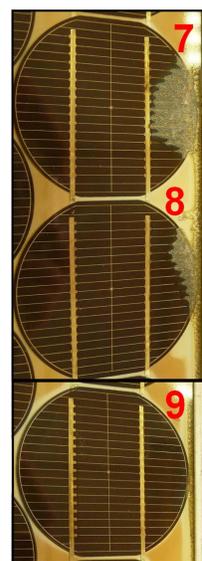
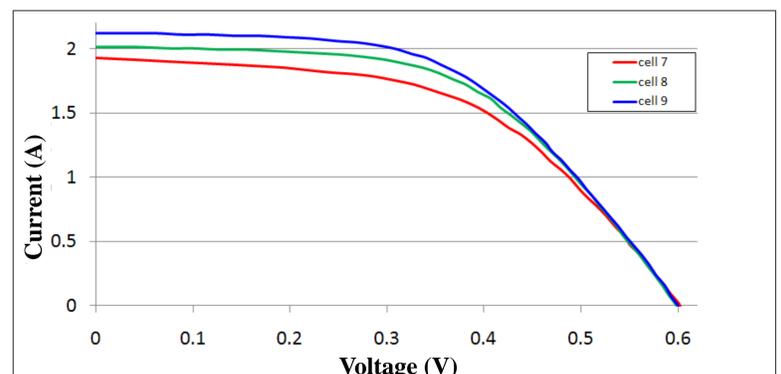
The correlation between modules electrical characteristics and visual defects allowed to determine which of the detected physical anomalies affect modules performance as shown in the following example for the encapsulant delamination.

Cell n°	% delaminated area	ΔP (cell 7 as reference)
7	12.3%	-10.6%
8	5.6%	-3.4%
9	0	0
